NASA Technical Paper 1081

Mechanical Behavior and Fracture Characteristics of Off-Axis Fiber Composites I - Experimental Investigation

John H. Sinclair and Christos C. Chamis

DECEMBER 1977

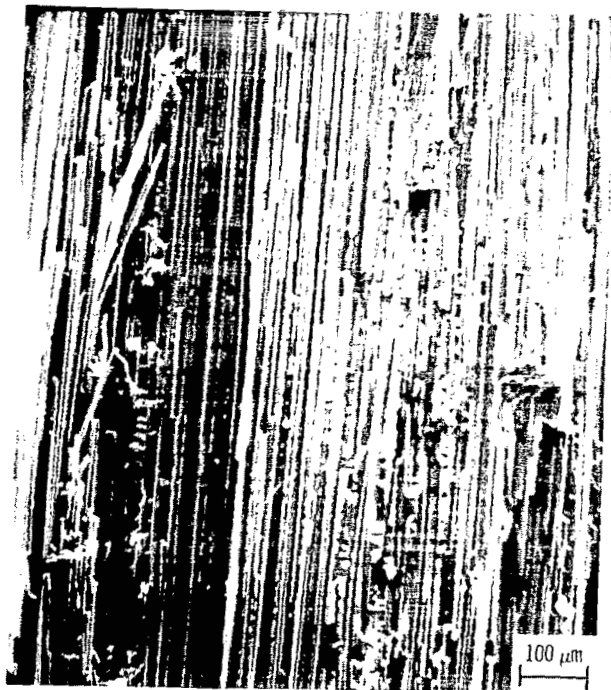
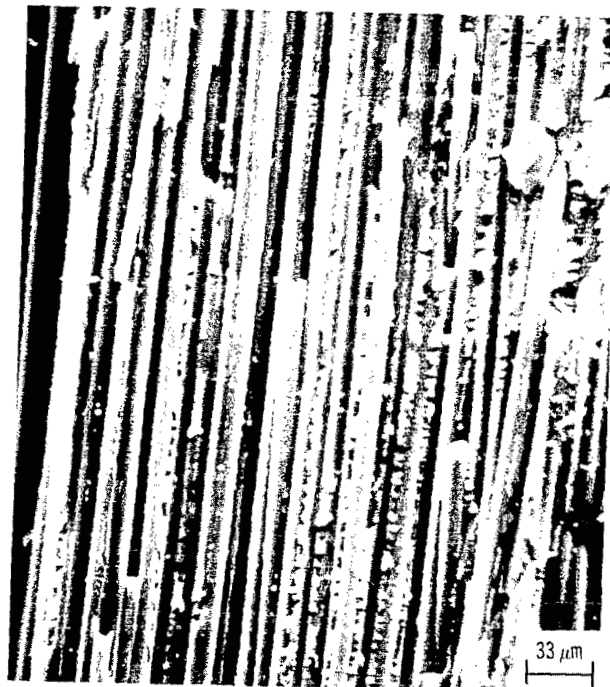
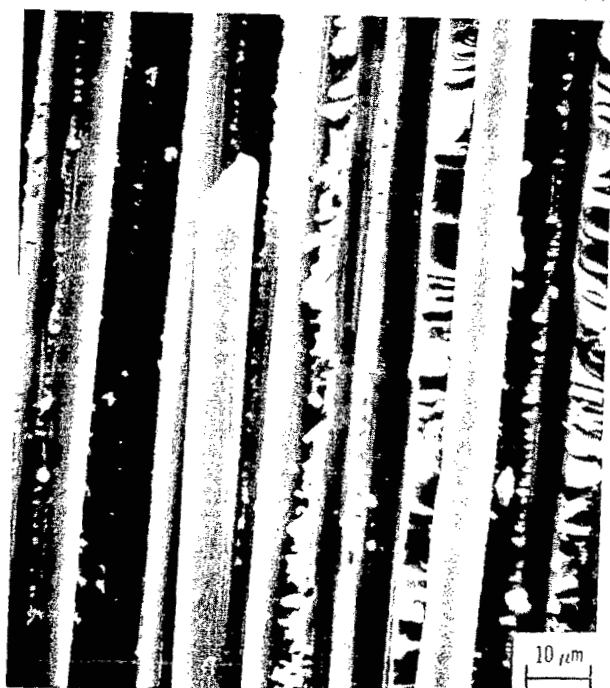
(a) General view.

(b) Detailed view.

(c) Enlargement of detail to show fracture mode.

Figure 20. - Scanning electron photomicrographs of fractured surface of Mod I/E composite tested at 30° to fiber direction.

The fracture surfaces of the 15° and 30° off-axis tensile specimens (figs. 19 and 20) reveal similar features to those of the 10° off-axis tensile specimen. These surfaces, too, indicate that fracture was induced mainly by intralaminar shear stress.

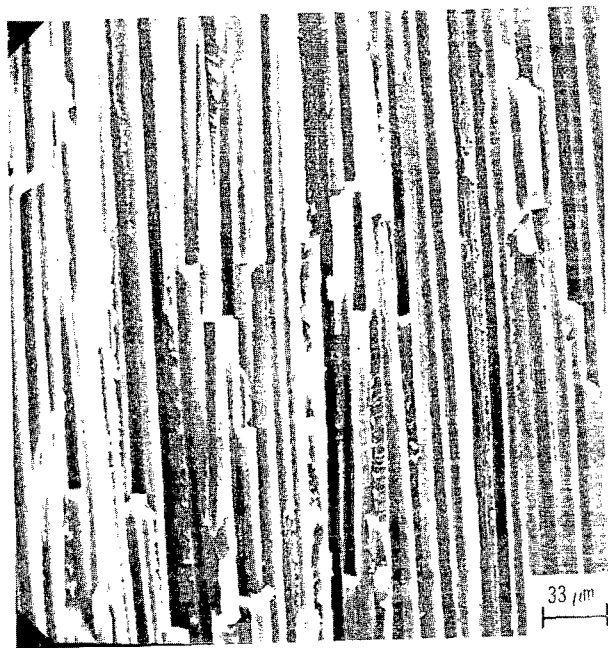
(a) General view.

(b) Detailed view.

(c) Enlargement of detail to show fracture mode.

Figure 22. - Scanning electron photomicrographs of fractured surface of Mod I/E composite tested at 60° to fiber direction.

The fracture surfaces of the 60° off-axis tensile specimen (fig. 22) and the 75° specimen (fig. 23) reveal mainly matrix cleavage and some fiber surface free of matrix residue; both of these features indicate that fracture was induced by transverse tensile stress.

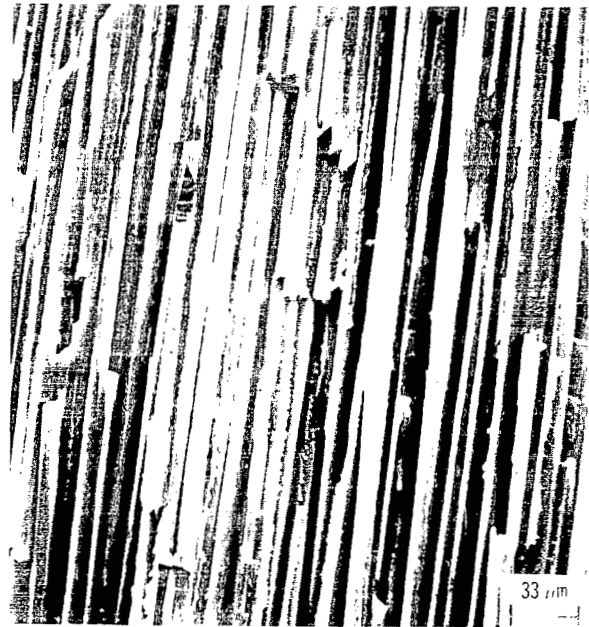
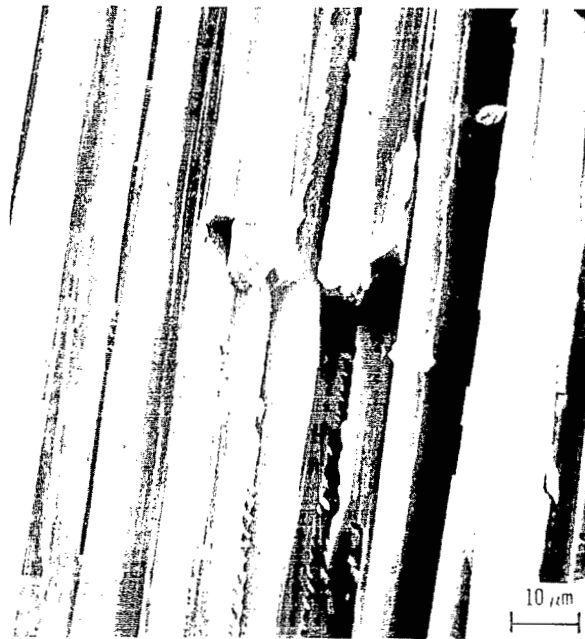
(a) General view.

(b) Detailed view.

(c) Enlargement of detail to show fracture mode.

Figure 23. - Scanning electron photomicrographs of fractured surface of Mod I/E composite tested at 75° to fiber direction.
